OH-6A MISHAP EXPERIENCE REPORT

OH-6 MISHAP EXPERIENCE REPORT

1 July 1967 through 30 June 1971

LOH Division
Directorate for Aircraft Accident Analysis and Investigation

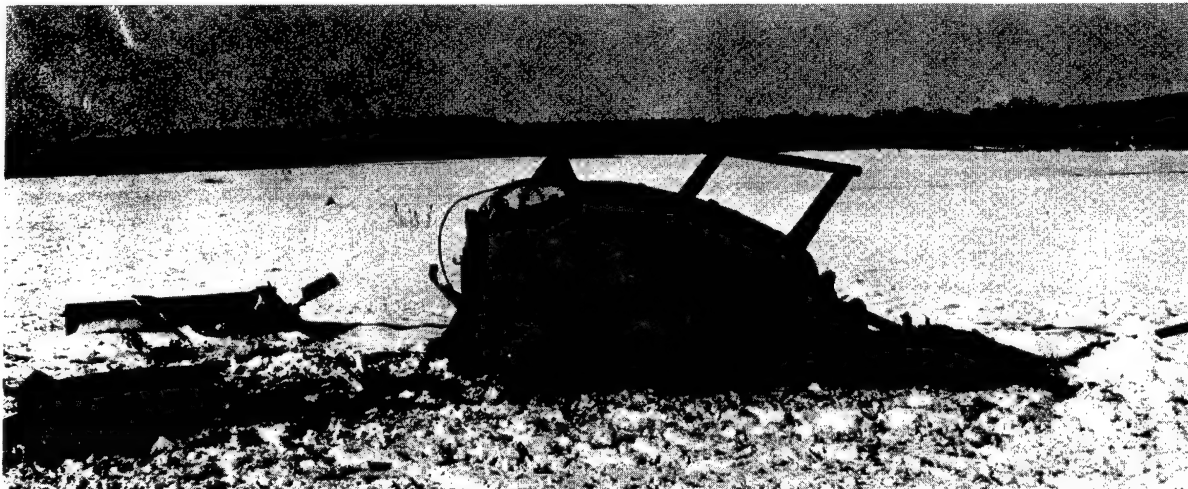
aircraft hit hard with a slight rearward motion and left side low. The two pilots sustained minor injuries and the aircraft was destroyed. The primary cause factor was listed as loss of ground contact due to heavy snowshowers and blowing snow from rotorwash. Suspected factors were a 30° wind shift, pilot disorientation, not making a go-around, and pilot's inexperience.

ACCIDENT NO. 1—Both pilots experienced vertigo in blowing snow.

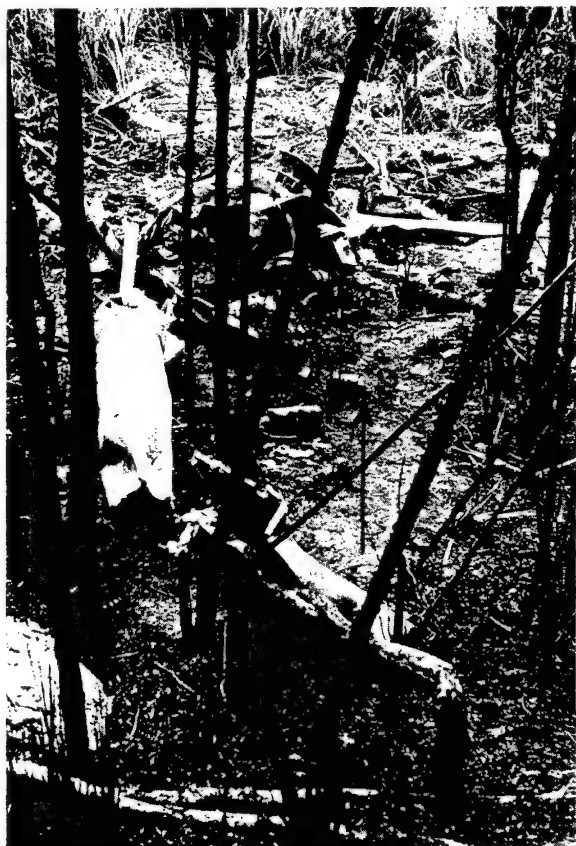
ACCIDENT NO. 4—Aircraft departed on staff reconnaissance mission. It was later seen to be descending at about a 30° angle. It crashed in a wooded area, exploded, and burned. The four occupants were killed. Suspect aircraft was in autorotation due to some failure, perhaps a fuel control or tail rotor malfunction.

ACCIDENT NO. 4—The four occupants of this aircraft were killed.

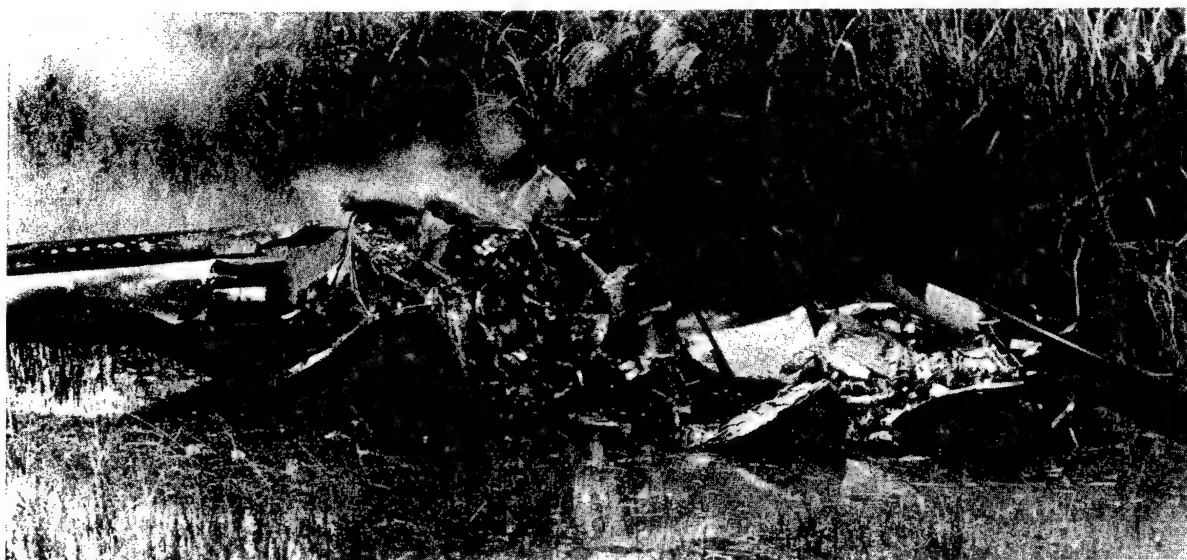
ACCIDENT NO. 6—Gunner was dropping fragmentation grenades from aircraft in attempt to destroy footbridge. Explosion occurred in passenger compartment and compartment was engulfed in flames. Explosive force knocked pilot's feet off pedals and broke out chin bubble. Emergency landing was made and pilot and observer escaped. Aircraft was consumed by fire with the gunner still in his seat. There was one fatality and one major injury. Aircraft was destroyed. Caused by gunner dropping live grenade on passenger compartment floor.

ACCIDENT NO. 6—Gunner dropped live grenade on passenger compartment floor.

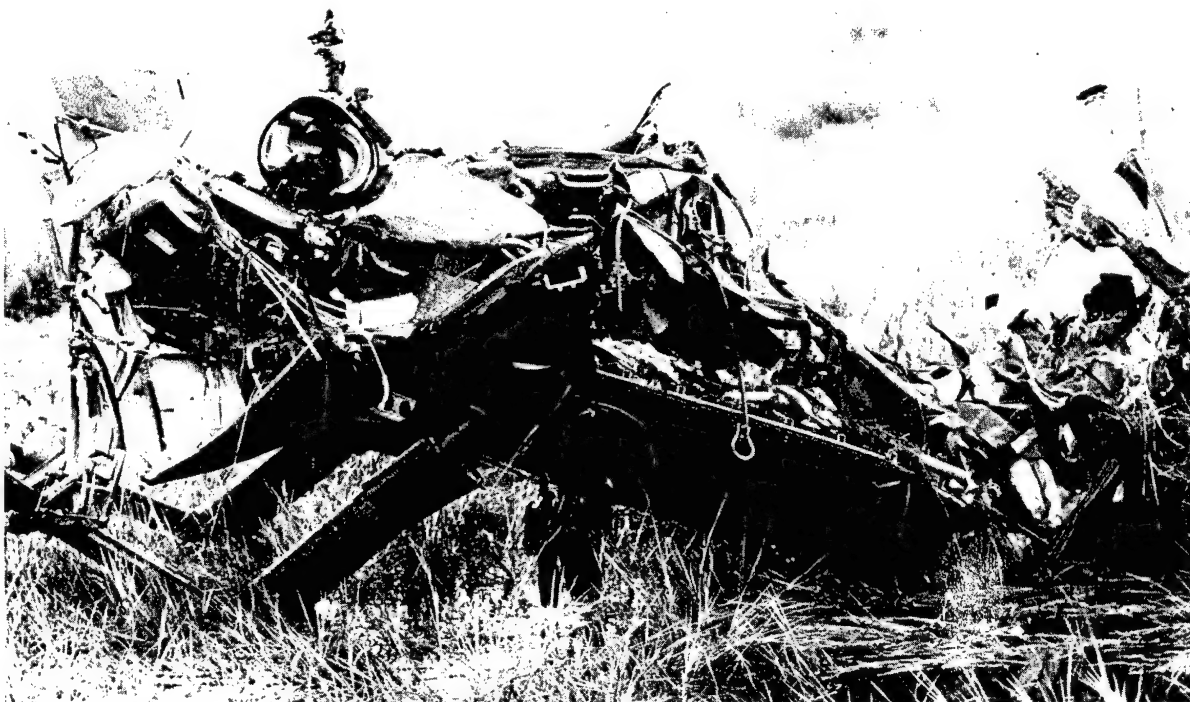
ACCIDENT NO. 7—Pilot accepted aircraft from maintenance and was returning it to his parent organization. Shortly after takeoff about 1730 hours, aircraft struck guy wire attached to 400-foot radio tower and disintegrated. The three occupants were killed. Suspect pilot was not familiar with the location of the towers and that the angle of the sun caused sun blindness.

ACCIDENT NO. 7—Aircraft struck guy wire attached to 400-foot radio tower.

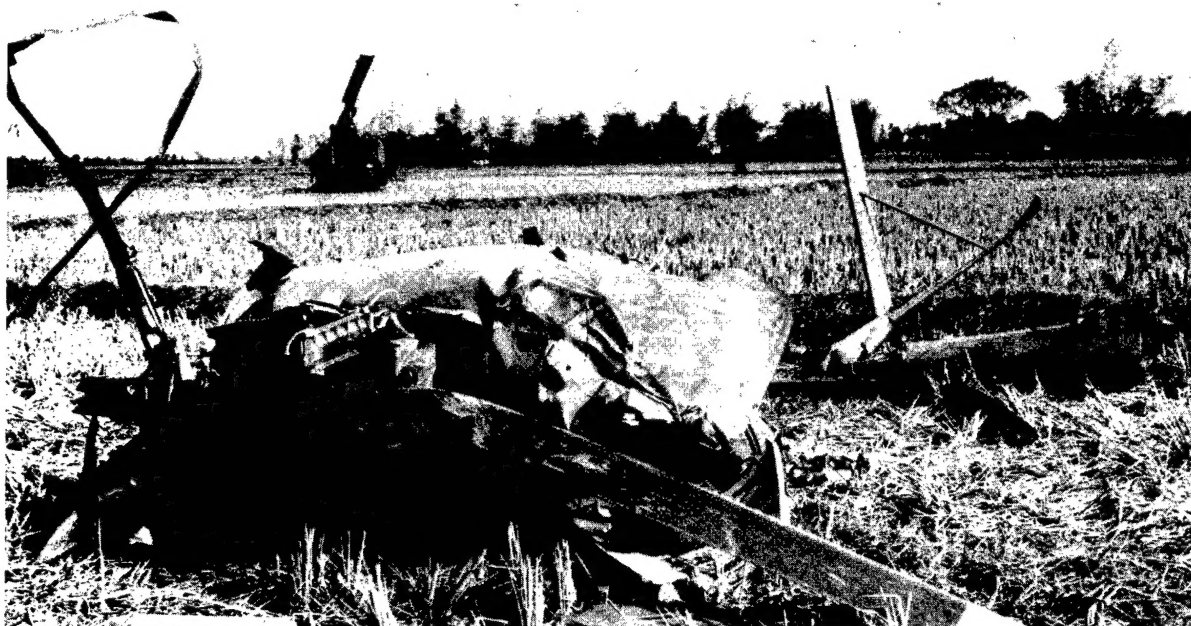
ACCIDENT NO. 9—Result of improper preflight, low fuel, and unnecessary and erratic low level flight.
